# An Experimental Insight on the Selection of the Tool Tilt Angle for Friction Stir Welding of 7075 T651 Aluminum Alloys

## Abstract

**Objectives:** To determine the optimum tool tilt angle for friction stir welding (FSW) Al 7075-T651 alloy plates by investigating the mechanical and metallurgical properties of the joints. **Methods/Statistical Analysis:** Al 7075-T651 plates of 6.5mm thickness are welded varying the tool tilt angle from 0 to 6 degrees. The mechanical properties like tensile strength and microhardness are evaluated. The testing of tensile specimens is done as per ASTM E8 M-04 standards. The Vickers hardness has been investigated at the weld center in the transverse direction. The microstructural changes occurring are studied with the help of metallographic inspection. Scanning electron microscopy (SEM) has been adopted to evaluate the fracture mode of the tensile specimens. **Findings:** An important welding parameter in FSW that influences the welding quality is the tool tilt angle. In this paper the results of Al 7075-T651 joints welded by FSW with varying tilt angle are investigated for their mechanical strength and metallurgical properties. Evaluation of the t

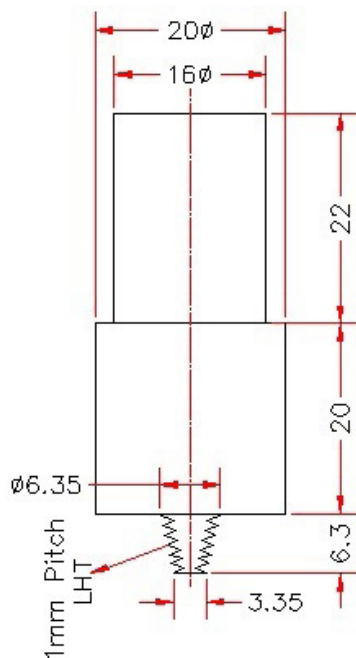
**Figure 1.** The FSW tool.

Al 7075-T651 alloy plates with a thickness of 6.5 mm were used in the study. The plates of 100 mm X 50 mm were used for the weld trials. The chemical composition of the materials plates used for the study is shown in Table 1. Table 2 depicts the mechanical properties plates. The welding tool used for the investigation is fabricated M2 grade high speed steel. The pin of the tool was machined to have a cylindrical tapered threaded pin feature. Figure 1 shows the dimensions of the tool. The machined tool was heat treated to achieve an hardness of upto 60 HRC. The tool material's composition is shown in Table 3.

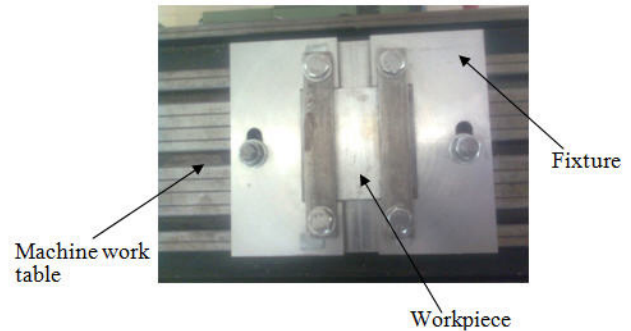
**Figure 2.** Workpiece and fixture.

The welding was conducted with the help of a vertical milling machine. Butt joint configuration is used to weld the plates. A specially designed fixture made from SS 304 to rigidly clamp the plates was used during the process. It also did the function of the backing plate. Figure 2. shows the workpieces clamped in the fixture.

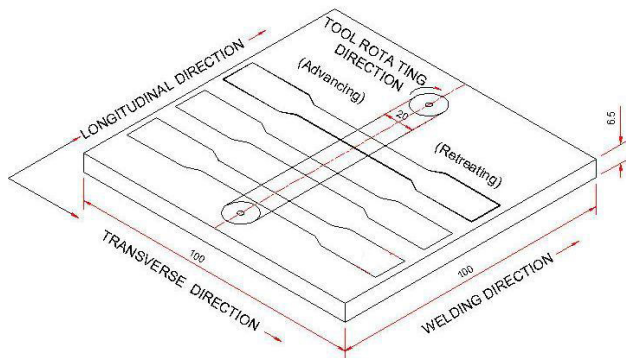
**Figure 4.** Schematic illustration showing the specimen layout to evaluate the tensile strength.

The specimens were normal to the weld line as shown in Figure 4. The average of the three tensile strengths has been reported.

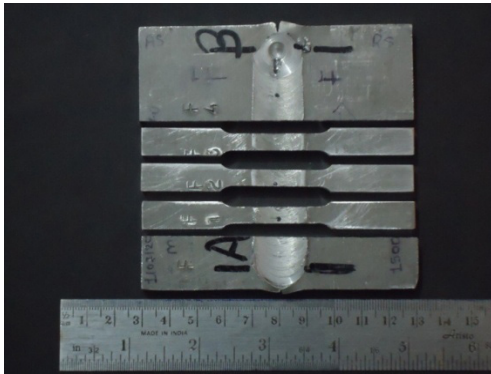
**Figure 5.** Tensile specimens of sample F.

A sample photograph of the tensile specimens prepared for sample F is shown in Figure 5. The tensile testing was done on a computer controlled 20 KN UTM

machine (Make: Tinius Olsen) with 0.5 mm/min constant head speed. The load was applied axially perpendicular to the weld line.

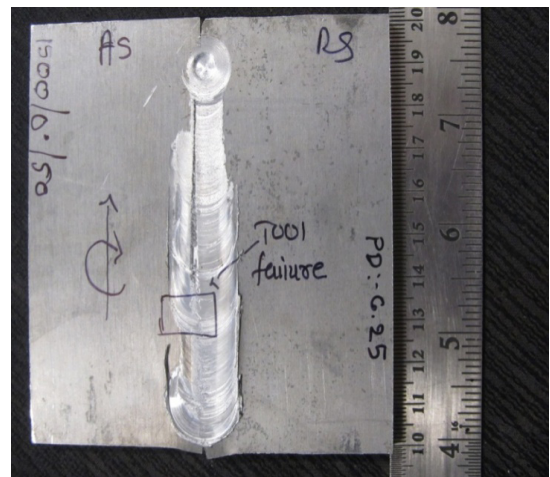
**Figure 6.** Test coupon welded at  $0^\circ$  tool tilt angle.

After welding the test coupons at various tool tilt angles, visual inspection was done to assess the quality of welding. It was observed that the friction stir welding done at  $0^\circ$  tool tilt angle resulted in the failure of the tool pin at the pin-shoulder interface. Figure 6 shows the pin failure inside the workpiece. The coupon welded with  $1^\circ$  tool tilt angle clearly showed weak or intermittent linking on the surface of the weld. Figure 7 shows the picture of test coupon welded at  $1^\circ$  tool tilt angle. The trials for  $0^\circ$  and  $1^\circ$  tool tilt angle were repeated but the welds were unsatisfactory. Hence coupons welded with  $0^\circ$  and  $1^\circ$  tool tilt angles do not qualify for further investigations. The visual inspection of all the test coupons welded with  $2^\circ$ ,  $3^\circ$ ,  $4^\circ$ ,  $5^\circ$  and  $6^\circ$  tool tilt angles showed acceptable quality of weld without any marked visual defects. Hence it was decided to go for further investigations of the joints welded with  $2^\circ$ ,  $3^\circ$ ,  $4^\circ$ ,  $5^\circ$  and  $6^\circ$  tilt angles.

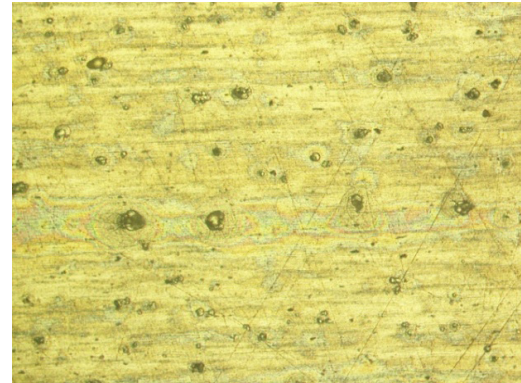
**Figure 8 (a).** Base material (200X).

Figure 8(a) depicts the microstructure of the parent metal comprising of insoluble second phase precipitates scattered in different areas. The grains are elongated in the rolling direction. Figure 8(b) evidently shows that FSW transforms the flat grains in the parent metal to fine-equiaxed recrystallized grains in the WN zone. This is a effect of elevated temperature and high rate of stirring action by the virtue of the tool pin. The bending of the grains in the thermo mechanically affected zone is due to the plastic deformation caused by the stirring action of the tool. The TMAZ is shown in Figure 8(c). The HAZ is the region where there no plastic deformation at all; the zone is significantly the result of frictional heating of the tool shoulder. Figure 8(d) indicates that in the HAZ the grain structure and the flow pattern did not significantly alter.

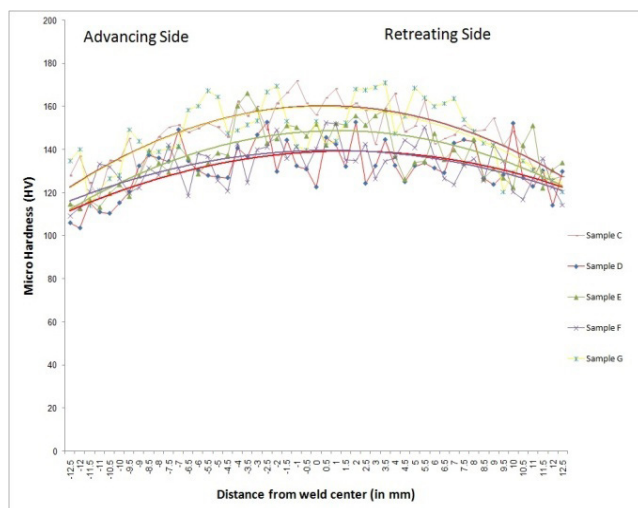
**Figure 9.** Effect of tool tilt angle on microhardness of Al 7075-T651 aluminium alloy.

The microhardness was measured in the center of the welds in the transverse direction. The measurement was done in the WN zone and the TMAZ. FSW results in coarsening and coarsening/dissolution of the initial hardening precipitates in the WN and TMAZ. This effect tend to reduce the hardness in the WN zone and the surrounding regions. In the present study also the weld nugget zone recorded higher values of hardness than compared to the TMAZ. Figure 9 shows the hardness distributions in different samples. The left portion of the profile shows the hardness distribution on the advancing side and the right part shows that of the retreating side.

The microhardness in the TMAZ and the WN were observed to be lower than the hardness of the base metal. The finer grain size in the WN zone compared to other regions being the main reason for this. As per the Hall-Petch equation, the hardness increases as the grain size decreases. A noteworthy reduction in the hardness value is seen in the TMAZ. This is because of the coarsening of the precipitates in the thermo mechanically affected zone. The minimum in the hardness was observed to be at around 12 mm on either side. Similar kind of observations have been made by Rajakumar et al.<sup>4</sup> From Figure 9 it is additionally revealed that there is a slight asymmetry in hardness values between the retreating side and the advancing side. The non uniform plastic flow resulting due to FSW is the major cause for the asymmetry in the hardness. In order to predict the behavior of the hardness data, a trend line is plotted for each of the hardness values. The trend line clearly depicts that the hardness values on the advancing side are lower compared to the retreating side for welding done with any tool tilt angles used. The maximum hardness was found to be of the sample C. Figure 10 shows the hardness distributions for sample C. The weld nugget zone recorded higher values of hardness than compared to other regions. The hardness in the weld nugget zone is in the range of 160 to 170 HV. It has been revealed in the literature available that the hardness measured on the cross-section perpendicular to the welding direction for friction stir welded heat-treatable aluminium alloys (in T6 or T7 temper condition) typically represents a “W-shaped” curve<sup>25-28</sup>. Figure 10 shows a typical “W-shaped” curve representing the hardness profile for sample C. Here, the hardness profile of all sample have exhibited the “W-shaped” curve.

For the present study the minimum hardness was found to be at about 12 mm on either side and the maxi-

imum hardness of about 160 -170 HV was noted in the WN zone. The major reason for this observed phenomenon might be the fact that dissolution is favoured both in the and WN and TMAZ during the process as a result of high temperature and strain rates. Whereas in the HAZ no plastic deformation is observed and the temperatures are considerably lower than the dissolution temperature of the precipitates. Hence HAZ is characterized by coarsening of initial hardening precipitates. The tendency to coarsen is much higher at the grain boundaries resulting in a precipitate free zone at and near the grain boundaries. This can be the major reason of sample C (no defects) getting failed outside the weld nugget. Whereas all the other joints have failed within the WN zone due to the weld defects. The size of the defects have increased with an increase in the tool tilt angle. The major reason for this can be attributed to the fact that, with an increase in

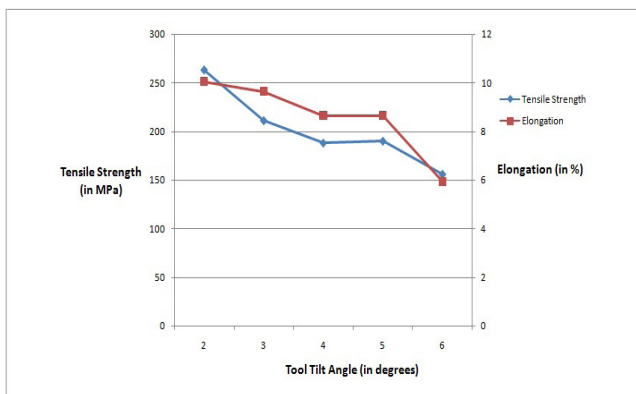
**Figure 11.** Transverse tensile strength properties of the welded joints.

The transverse tensile strength tests of all the welds were undertaken. From each weld coupon, three specimens were tested. The average tensile strengths and percentage elongations of the three samples are presented in Table 6. The maximum joint strength was exhibited by the weld made at 2° tool tilt angle. The maximum strength of the weld was 263MPa with an elongation of 10.06%. The tensile strength and the elongation were observed to decrease with the increase in tool tilt angle. It has been observed that when the tool tilt angle is greater than 3° the tensile properties of the joints decreases to considerably low lev-

els. The same is reflected in Figure 11. Additionally it was also observed that apart from sample C which failed in the TMAZ of AS, all the other joints failed in the WN zone.

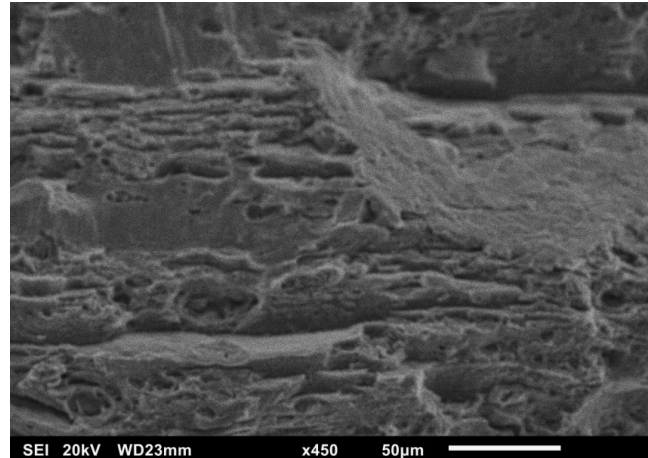
**Figure 12.** SEM micrograph of fracture plane of Al 7075-T651 parent metal.

It is certain that the fusion welded heat treatable aluminum alloys are accompanied by welding defects like porosities and inclusions<sup>29</sup>. FSW takes place in solid. Hence FSW joints are free from such defects. The major defects that FSW joints are prone to are excessive flash, voids, wormholes, excessive concavity, lack of penetration, and kissing bond defects. SEM is used to study the failure patterns of the fracture surface of the tensile specimens. Figure 12 shows the fracture surface of the unwelded parent metal indicating an approximately equiaxed pattern and confirms the superior mechanical properties of the joint. It reveals that the specimen has failed in pure tensile mode.

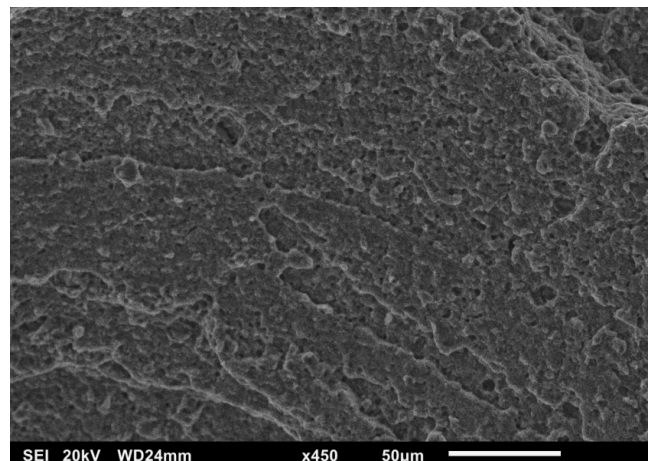
**Figure 13.** SEM micrograph of fracture plane of joint welded with 2° tilt angle.

The fracture surfaces of the welded specimens (viz. samples C, D, E, F and G) have been captured and are shown as Figures 13 -17. Microstructure analysis showed that sample C had no weld defect hence the failure of tensile specimens for sample C was in the TMAZ away from the weld nugget zone. Whereas the presence of defects in the weld nugget zone of the other joints is the major reason for the failure of these joints. Figure 13 shows fracture surface of sample C with the presence of pits defining a ductile mode of fracture.

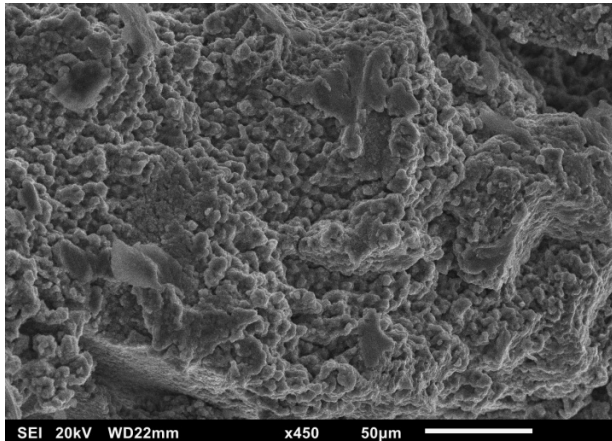
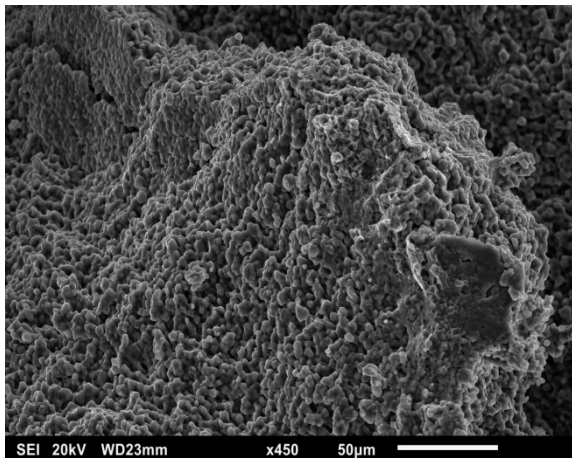
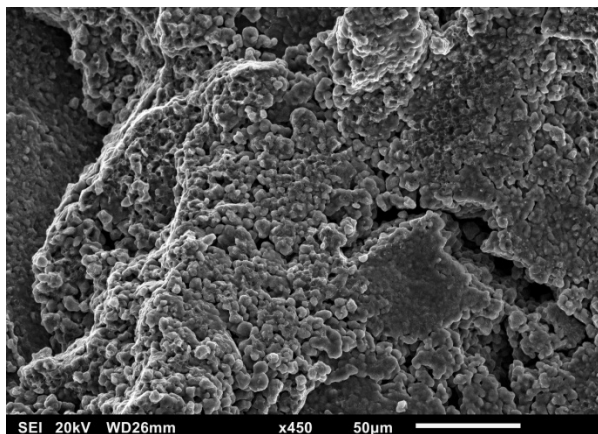
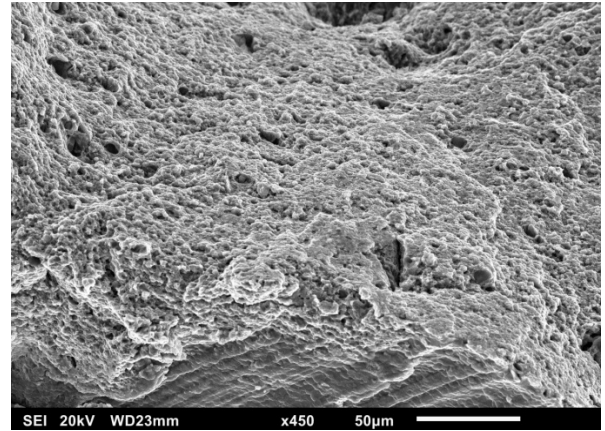
On the contrary, a brittle fracture is found in all the other joints. Fracture surfaces (Ref. Figures 14 - 17) observed under SEM for the samples D,E,F and G shows an uneven surface accompanied with fibrous tedious

appearance which are clearly characteristics of a brittle fracture.
