**Citation:** Wahidi AW, Abdul Rahman MS, Aasim BA, Karimi AK (2025) Structural Health Assessment of Composite Steel Beams: Evaluating Pre-Damage and Post-Damage States using Modal Analysis. Indian Journal of Science and Technology 18(30): 2472-2481. <https://doi.org/10.17485/IJST/v18i30.1163>

## Structural Health Assessment of Composite Steel Beams: Evaluating Pre-Damage and Post-Damage States using Modal Analysis

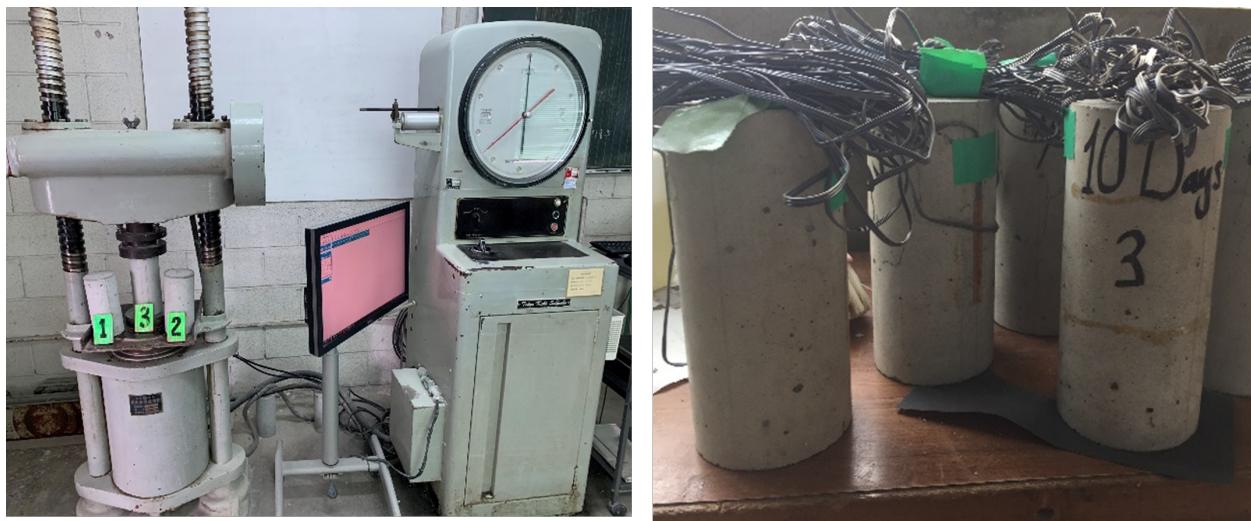
Fig 1. Tested samples of concrete

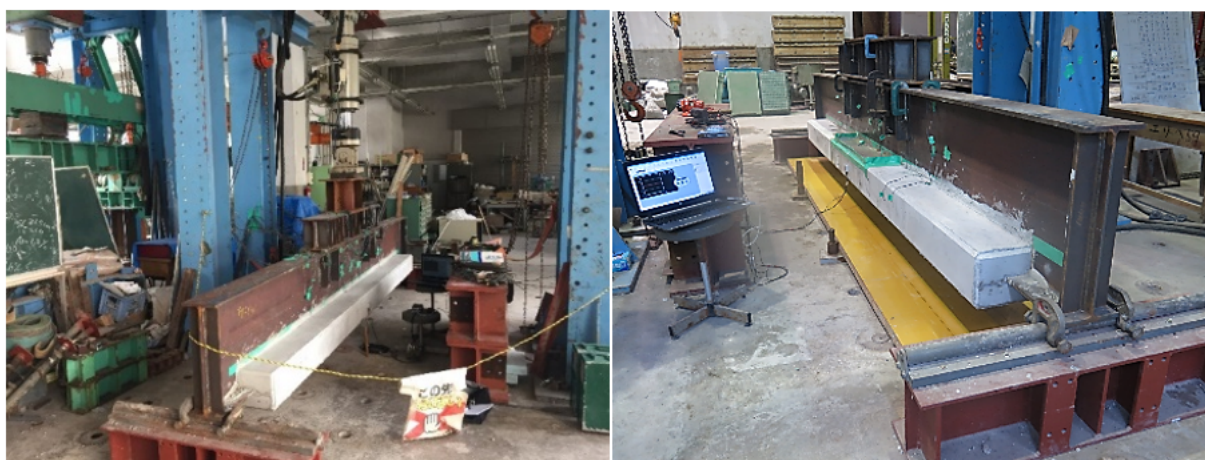
environmental noise and interference. Figure 6 and Figure 7. illustrate the bending load configuration and data recording of the post-damage state of the girder.

**Fig 7.** Data acquisition of post-damage state of the girder
